017: EPIRB Break Off Tab Replacement

Introduction

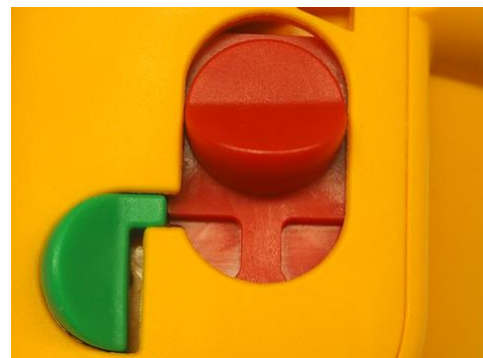
Remove the old cover and move the red key down about half way. (this requires sliding the green key sideways first as for normal activation.) Remove any broken pieces from the slots.

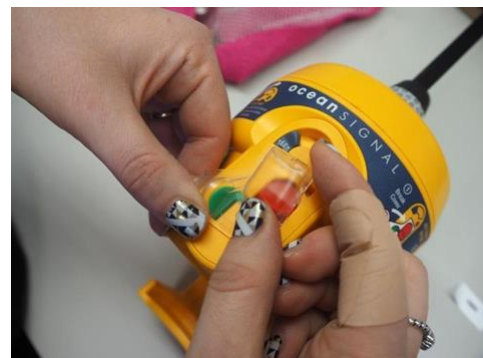
Offer up the clear cover, locating the round lug at the bottom first. With the clip at a slight angle (anticlockwise from the top), press the clip at the bottom into the oval recess. This is the tricky bit and takes a little trial and error! The only problem is an error usually breaks the clip.

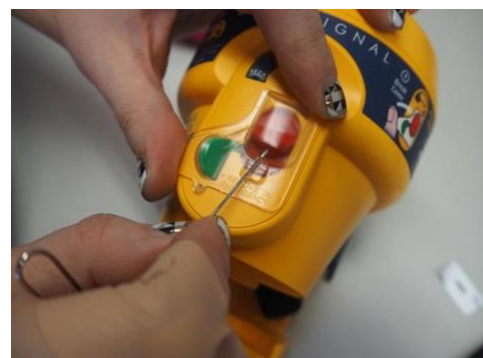
The cover should now lie flush to the surface if all is well. To slide the red key back to the off position, open up a paper clip and poke it into the small hole in the bottom of the cover and push upwards. The clip should now be in place.
